**FOCUS ON MECHANICAL FAILURES:**

**MECHANISMS AND DETECTION**

**Proceedings of the 45th Meeting  
— of the  
Mechanical Failures Prevention Group**

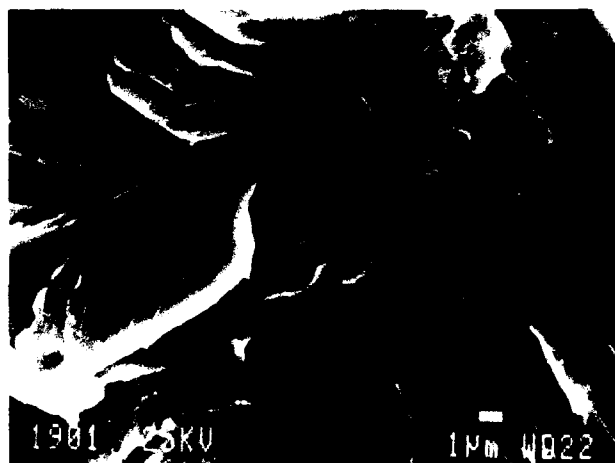
Fig. 6. Typical crack reinitiation sites observed on the fracture surface of a galvanized structural steel bar. Crack reinitiation is situated at the grain boundaries and at times at or near inclusions at these boundaries. Fig. 6a shows an inclusion at the initiation site and a few line-markings near this site.

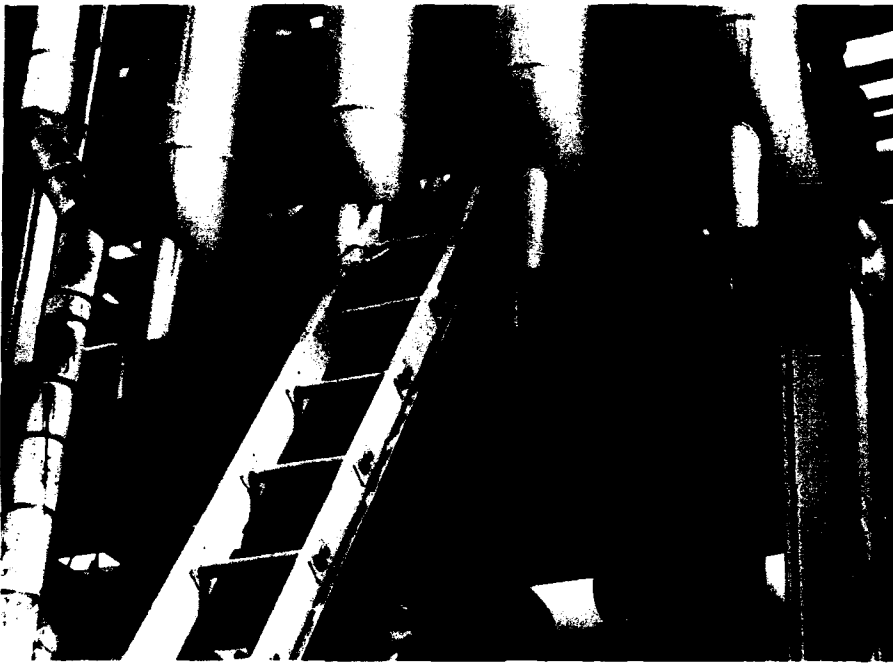
**Photograph 2**

**View Looking East of the Discharge  
Pipes and the Channel Supports**

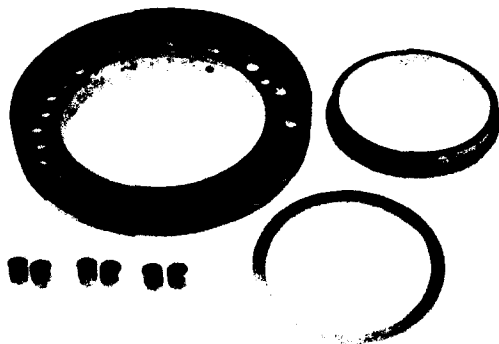
Figure 1 1:4  
Photograph showing a damaged cylindrical-roller-bearing in addition to separate components;  
a) outer-ring; b) inner-ring;  
c) rollers.

The straight-roller-bearing ("A"), shown in figure 1, showed the same damage at the outer-ring, inner-ring and the two cylindrical rollers. The damaged areas found on "A" were about one tenth of a millimeter, orientated in the direction of bearing rotation, and appear as striation lines. SEM-investigation show that the local and periodic damaged areas were craters formed from melting (figure 2).

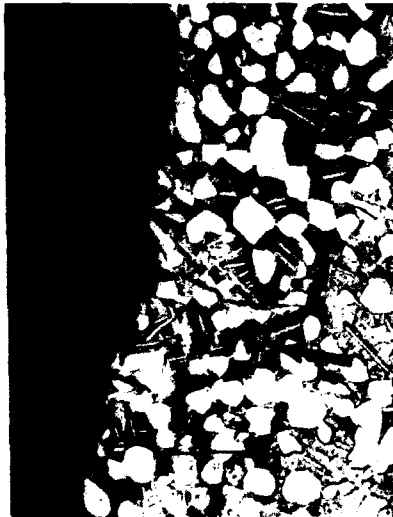
9. Photomicrograph of an area closer to the fracture face than those depicted by Figures 7 and 8. Note the presence of the crack and coloration (shown by the arrows). One per cent HF etch. Mag 1000X
